Preliminary Permafrost and Hangar Investigation

Naval Arctic Research Lab, Barrow, Alaska

July 2012

Final report

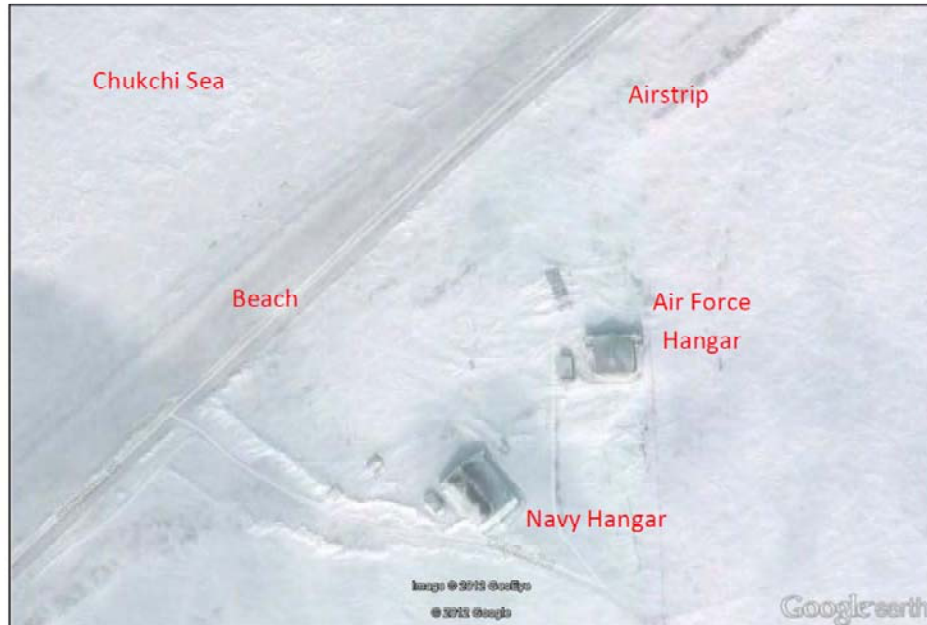
Figure 1. April 2009 aerial view of hangar layout (scale 1 in. = 800 ft, north at top).

We visited the hangars on 12 July 2011 for a full afternoon, and were allowed to investigate all areas. The first hanger visited was the “Navy” hangar (Fig. 1–4), and the second hangar was the “Air Force” hangar (Fig. 1, 5, 6, 7). The Navy hangar is located approximately 1000 ft inland from the beach at the southwestern end of the runway. The Air Force hangar is located approximately 500 ft northeast of the Navy hangar and slightly closer to the runway. The Navy Hangar is approximately 200 × 160 ft (L × W) with office and storage space at the rear, and the Air Force Hangar is approximately 130 × 130 ft with no office or storage space. Because of the sandy nature of the surface soils, interlocking steel aircraft matting was laid on the entire runway surface, the entire surface of the ramps and aprons leading to the hangars, and entirely within the hangars for floor-

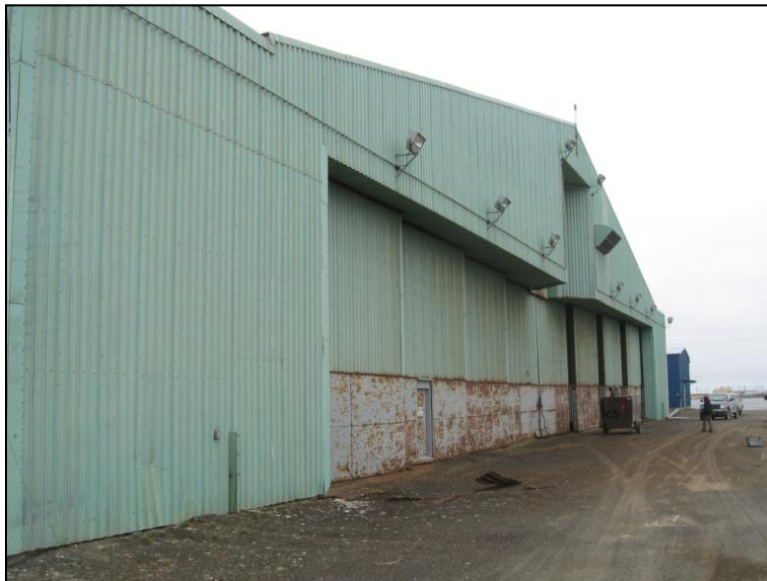
Figure 2. Front wall of the Navy hangar (level and plumb lines throughout).

The interior floor of the Navy hangar was in disarray from soil remediation work that was conducted inside during the 1990s, so there was no visible evidence of floor settlement mentioned earlier. We were told by personnel familiar with the hangar that the main sliding door on the front of the hangar was not operative, but this could be attributable to no electric power remaining to the structure, and not a misaligned track or settlement along the threshold. Visual examination of the monolithic stem wall and pile caps revealed no distress. No cracking of the concrete of the wall or caps was visible (Fig 4). No separation was visible between the steel truss columns and the stem walls, which might indicate movement. All walls and corners appeared plumb, and all eave and ridge lines appeared level. The exterior metal cladding had no visible signs of warping or separation, and the soil fill around the outside of the stem wall was level with no visible signs of settlement. Overall, this hangar gave an appearance of being in suitable condition.

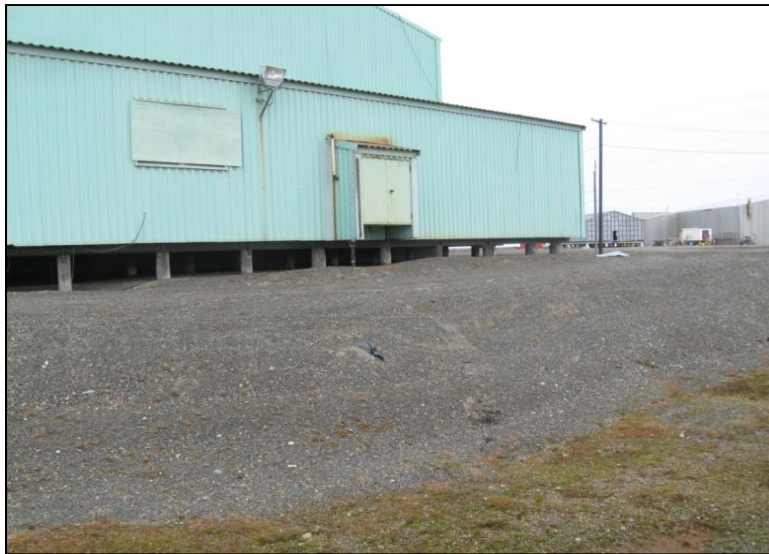
Figure 3. Back wall of the Navy hangar with office and storage. Note the gravel fill thickness of 4 to 5 ft above the native soils.

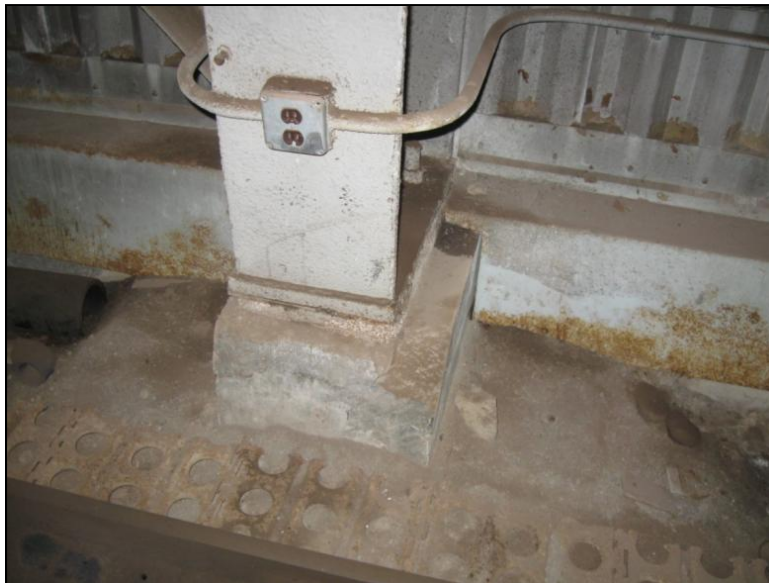
Figure 4. Navy hangar. This is the roof truss column where it rests on the pile cap. Note the concrete stem wall in the background. No cracking or separation was found at these junctions.

- The Air Force Hangar was the first to be constructed, in the late 1940s when NARL was first constructed. The Navy Hangar was constructed in the 1960s.
- The hangars are constructed on approximately 4 ft of structural fill (screened gravel), over ice-rich permafrost. It is unknown if the vegetation was removed prior to placement (Fig. 3).
- The load bearing end walls of both hangars rest on monolithic concrete stem walls. This wall rests on concrete pile caps, which then rest on piling installed to at least 10 ft deep (Fig. 4, 8).

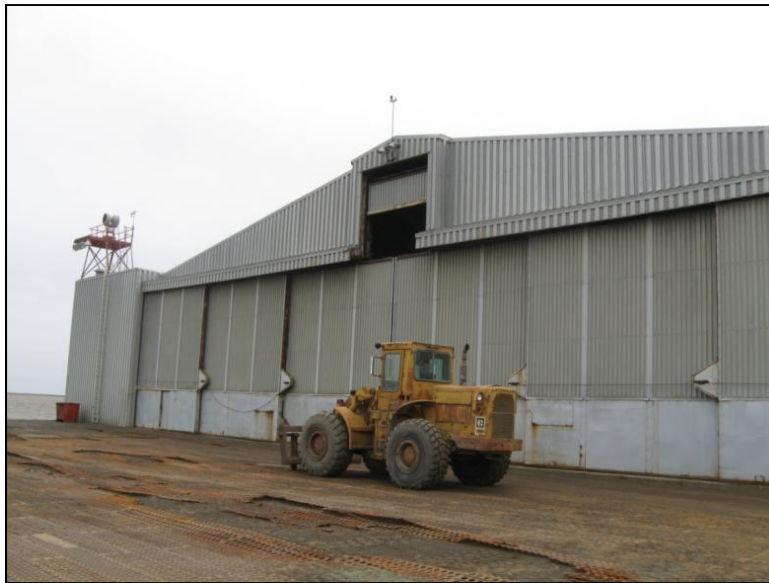
Figure 5. Front view of the Air Force hangar (level and plumb lines).

The Air Force hangar was rougher in appearance than the Navy hangar, but upon closer inspection this was mainly because of the deterioration of the outside cladding, which was missing in places, most probably because of wind, and damaged in other areas from equipment impacts. Otherwise, the same observations mentioned above for the Navy hangar apply to this hangar as well. The steel floor matting was intact in this hangar and did exhibit an undulating surface, with a wavelength on the order of tens of feet, and a maximum wave height of 1.0 ft, crest to trough, measured during this investigation.

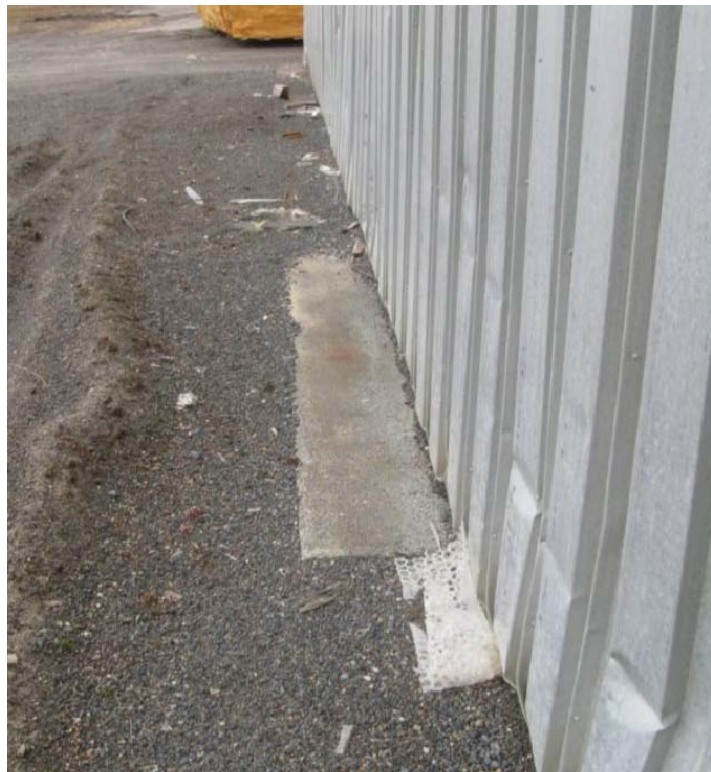
Figure 6. Pile cap exposed along the outside wall of the Air Force hangar.

The information provided by John Schindler, and the visible pile caps at each hangar, indicate that both hangars may have been constructed in a similar fashion, with perimeter pile systems extending to some depth into the permafrost. A similar type foundation system exists in the hangars at Thule Air Force Base, Greenland (Fig. 8). Although the soils at Thule consist of greater portions of all particle sizes (silt to cobbles), the climate is very similar, with similar permafrost temperatures at 11 to 12°F. In some of the Thule hangars, extreme thaw settlement (5 to 6 ft) had occurred in the floors. However, because the piles systems extended to sufficient depth, and along the perimeter of the structure, the load bearing, frozen soils were not affected by the thaw bulb progression under the floor (Fig. 9). Therefore, there was no thaw settlement causing structural distress in the superstructure (Bjella 2010). It is hypothesized this may be the case with both the hangars at NARL.

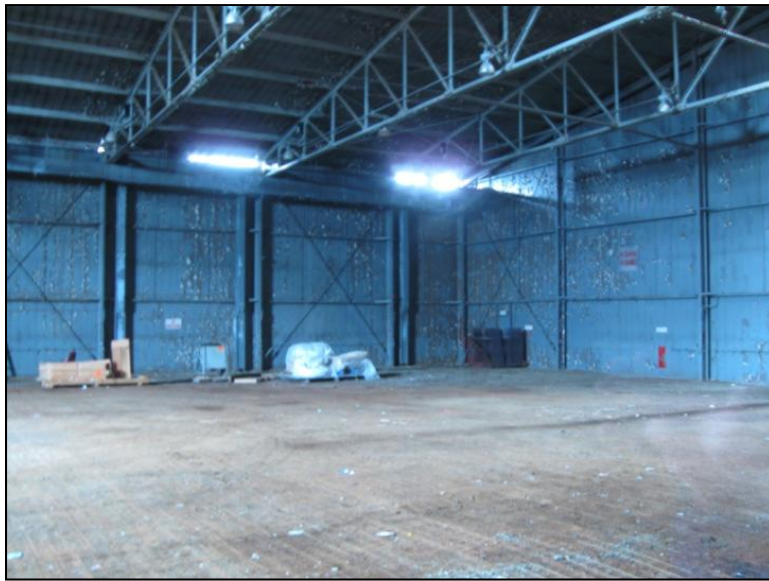
Figure 7. Interior view of the Air Force hangar.
